Model: IC-7610

Subject: ADC Heat Sink Detachment

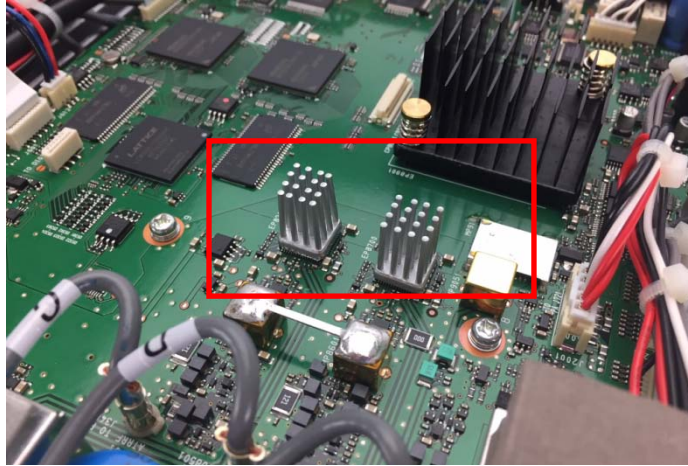
It has recently come to the attention of Icom America, that in rare circumstances, heat sinks attached to RF-ADC IC8200 and/or IC8700 next to the Main CPU on the main board may become slightly dislodged. This is a rare occurrence and we have found that IC-7610 radios within S/N range of 12001000 – 12003470 could be susceptible.

The heat conduction tape that attaches the heat sink to the RF-ADC chips 8201 and 8701 wasn't adequately pressed onto the chips, resulting in loose heat sink components.

Remove the bottom panel of your IC-7610 and inspect the heat sink on the 2 ADC chips (next page). If a heat sink is loose, you have several options:

- Option 1:** While looking at the heat sink, carefully but firmly apply pressure to the heat sink, taking care not to over exert and stress the chip or Printed Circuit Board (PCB). This will allow a firm connection between the heat sink and chip. Once that is done, you can close the radio up and operate normally.
- Option 2:** You may contact Icom America Parts Department by phone or email to obtain new thermal sheet tape that sticks the heat sink to the ADC chips. Please be prepared to verify ownership of your IC-7610 when contacting:
